Accolade TMZF trunnion corrosion and mechanical failure 9 yr after primary surgery: A case report and treatment options

Matias Hemmilä, MD, Mikko Karvonen, MD, Hannes Keemu, MD, Matti Seppänen, MD and Keijo Mäkelä, MD, PhD

Department of Orthopaedic Surgery, University of Turku and Turku University Hospital, Turku, Finland

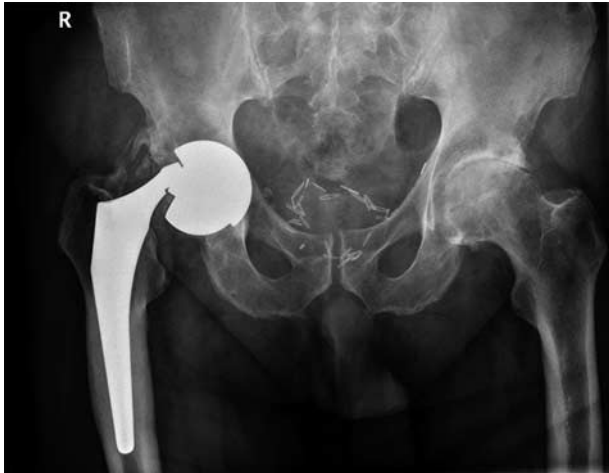
The patient was totally asymptomatic in the right hip for 9 yr until he stood up from the chair and suddenly felt right hip pain and was unable to bear weight. The radiographs showed dissociation of the femoral head from the trunnion and probable trunnion damage (Figure 1). The re-revision was performed 2 days later, and the stem was revealed. Some metallosis was found in the joint, but no pseudotumor was evident. The trunnion was corroded and severely damaged meaning the stem needed to be replaced (Figures 2 and 3). The stem was well-fixed, and an extended trochanteric osteotomy of the femur was performed. The stem was replaced with a modular Arcos revision stem (ZimmerBiomet, Warsaw, IN). A 12-mm x 150-mm STS distal bearing stem and a cone B60 high-offset proximal part was used. The cup was exposed. Since it was in an acceptable position and was well fixed, the cup was retained to avoid possible damage resulting from component removal. A 56-mm dual mobility system was used to prevent damage and dislocation (Figure 4).

FIGURE 1. Anteroposterior radiograph presenting dissociated femoral head from the trunnion after a total hip arthroplasty.

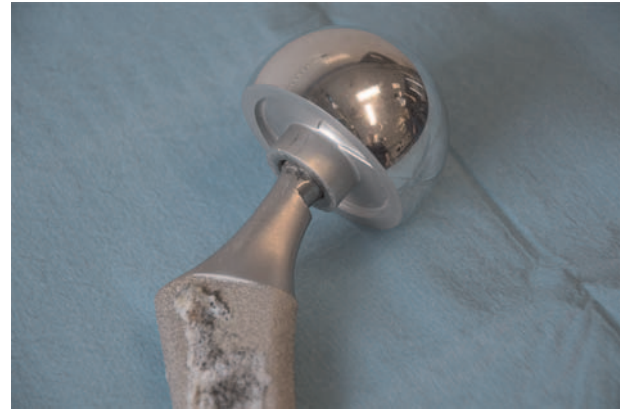
FIGURE 3. MITCH 50-mm + 8-mm head and Accolade® TMZF®-stem with femoral neck wear.

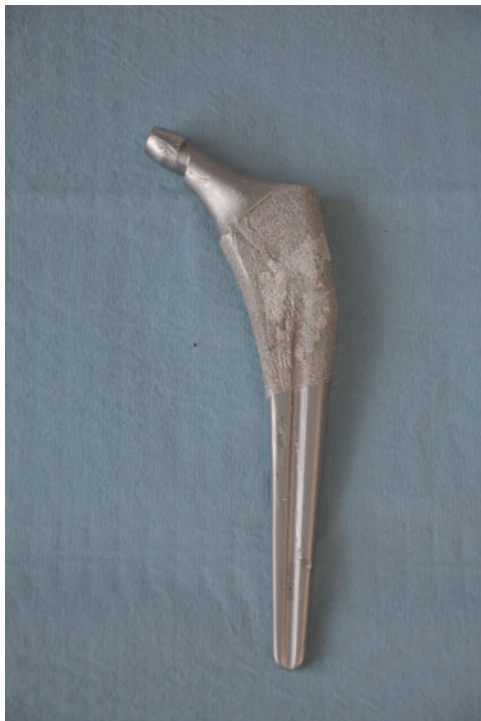
FIGURE 2. Severe trunnion corrosion and wear of the Accolade TMZF stem.

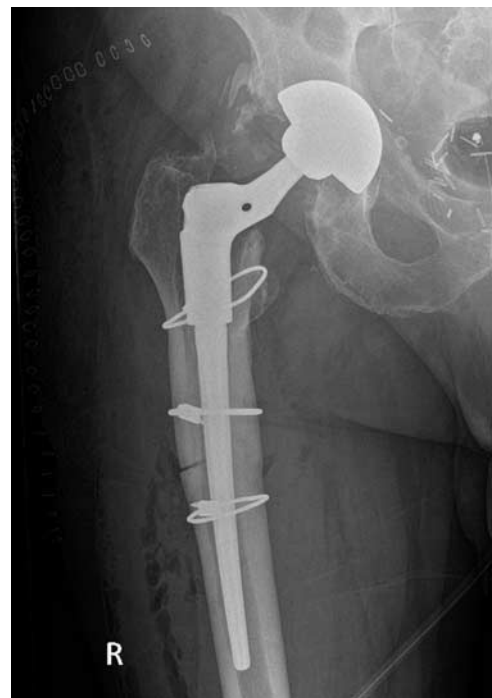
FIGURE 4. Anteroposterior radiograph showing the outcome after revision operation with Arcos 12-mm x150-mm STS distal bearing stem and a cone B60 high-offset proximal body.
