AlCl_3 -treatment of eutrophic Lake Littoistenjärvi: Background and interim results Heikkilä J. & Vepsäläinen M.

SYKE SEDIMENTTISEMINAARI -Lake restoration using aluminium salts: recent advances, results, and potential hurdles, Helsinki, 5.6.2017

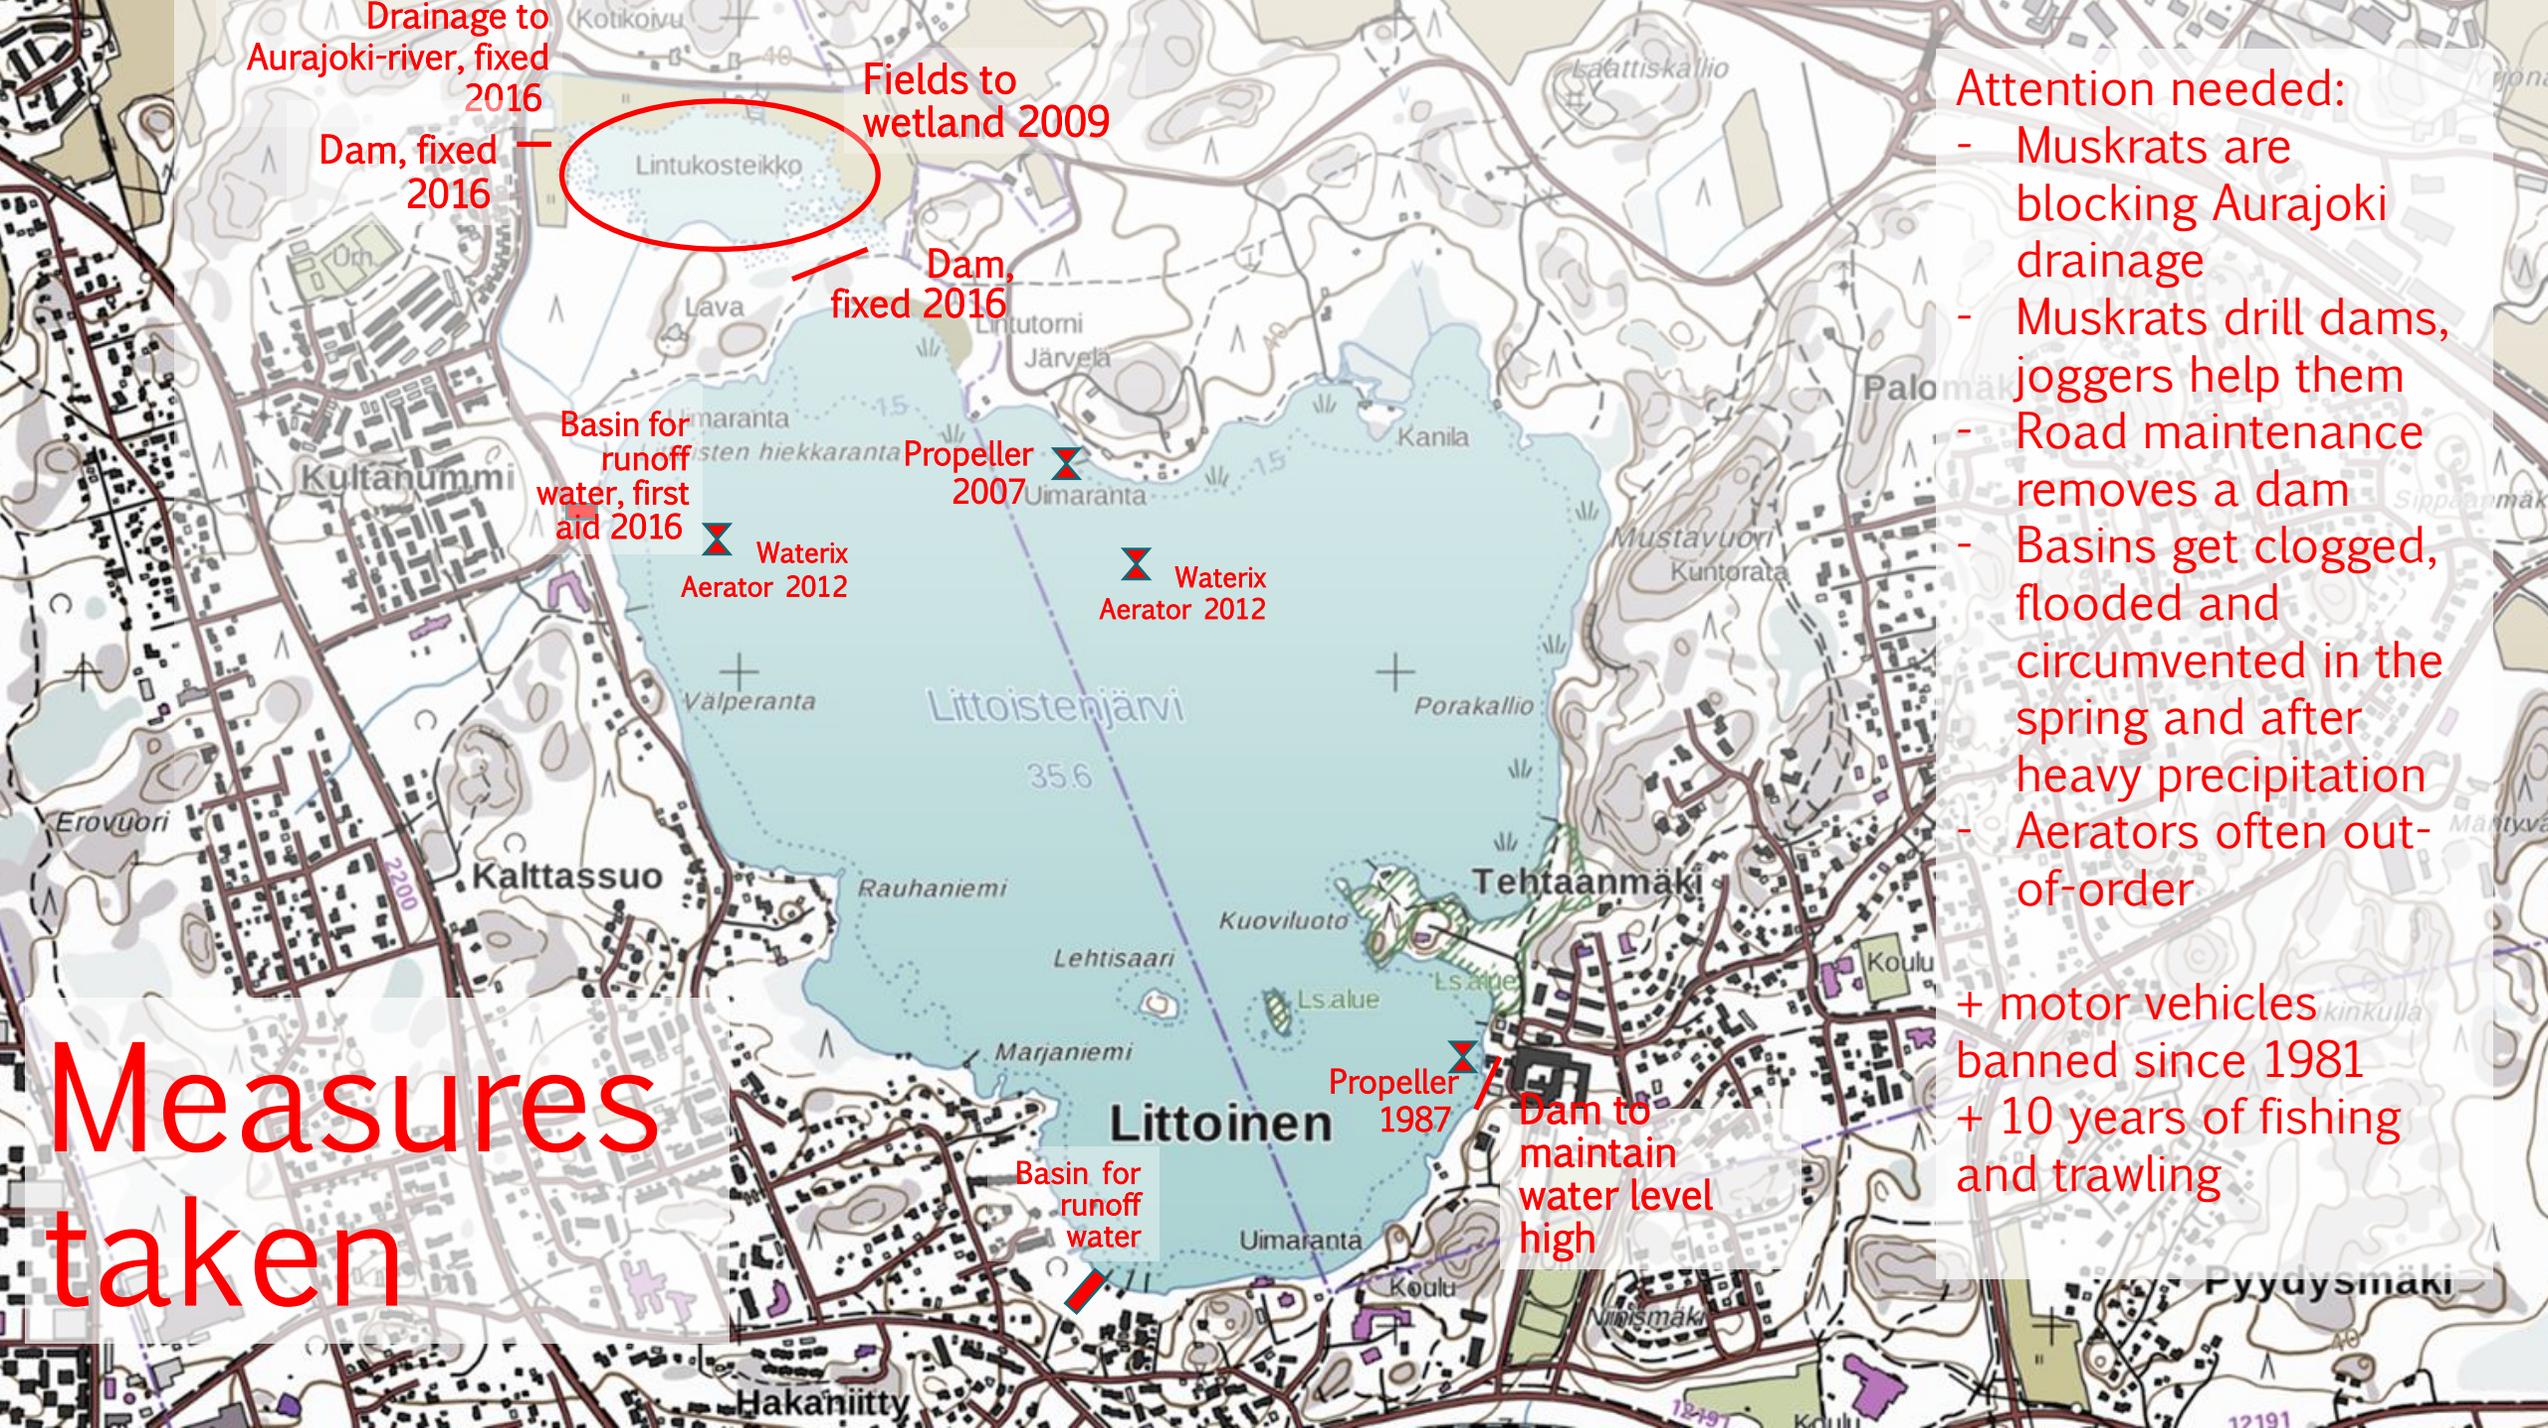
Drainage to Aurajoki-river, fixed 2016

Dam, fixed 2016

Fields to wetland 2009

Basin for runoff water, first aid 2016

Waterix Aerator 2012

Propeller 2007

Measures taken

- Muskrats are blocking Aurajoki drainage
- Muskrats drill dams, joggers help them
- Road maintenance removes a dam
- Basins get clogged, flooded and circumvented in the spring and after heavy precipitation
- Aerators often out-of-order

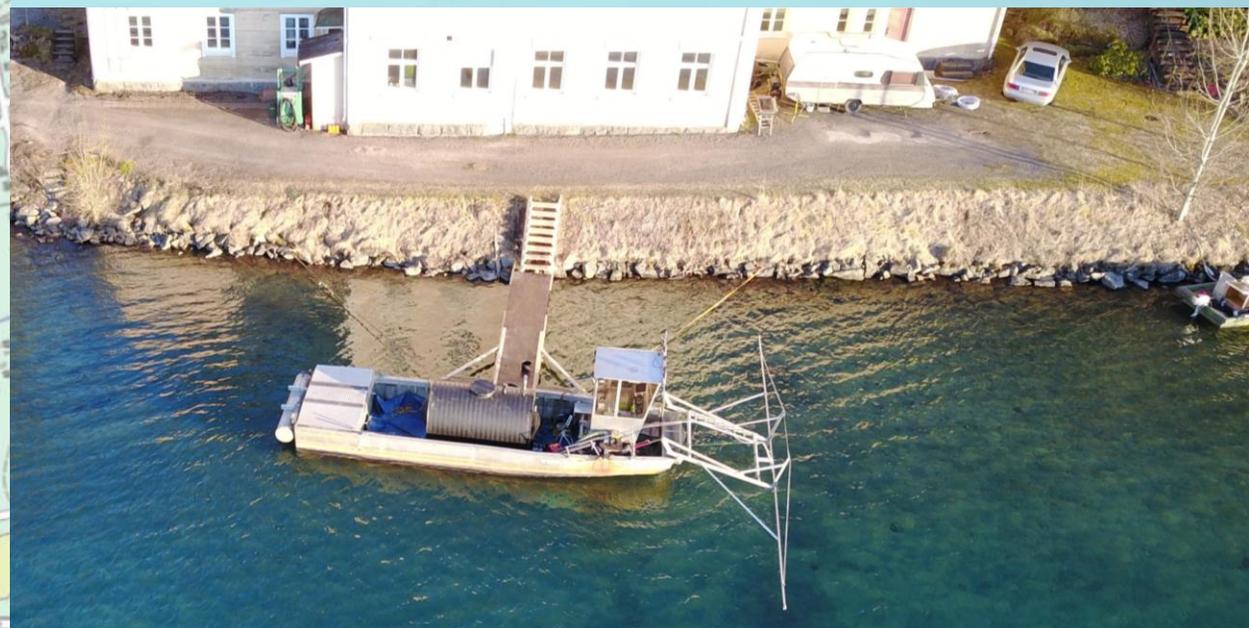
pH details

Short pH spreading time (20 hrs) and gathering daily winds (4 m/s; 8-10 m/s in gusts) mean that solution spreads out unevenly, close follow-up needed.

- On 6.6.2017: pH 6,8...7,0

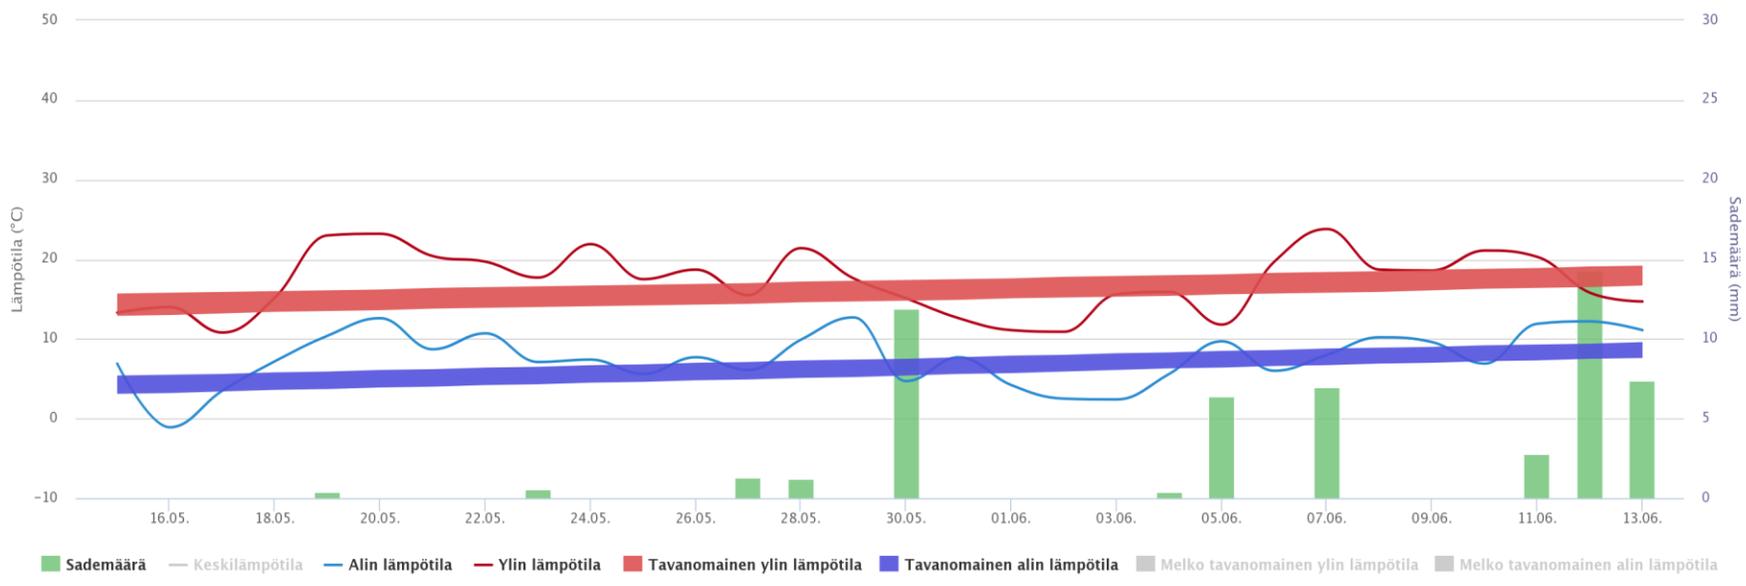
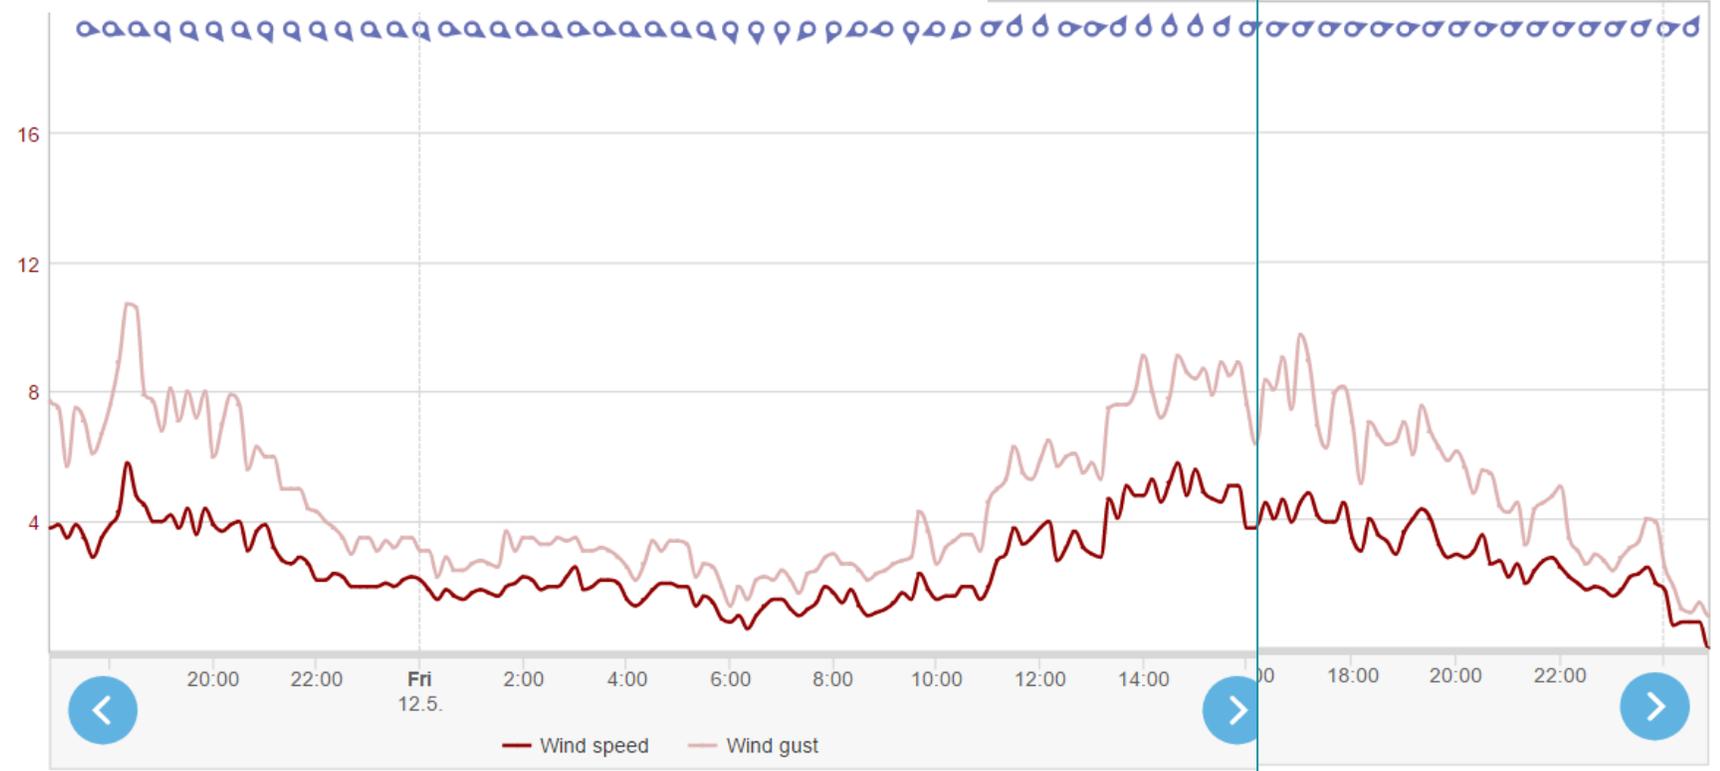
Weather Artukainen during treatment

1010-1017 hPa

-3,0...+10 °C

Varying winds 0...10 m/s

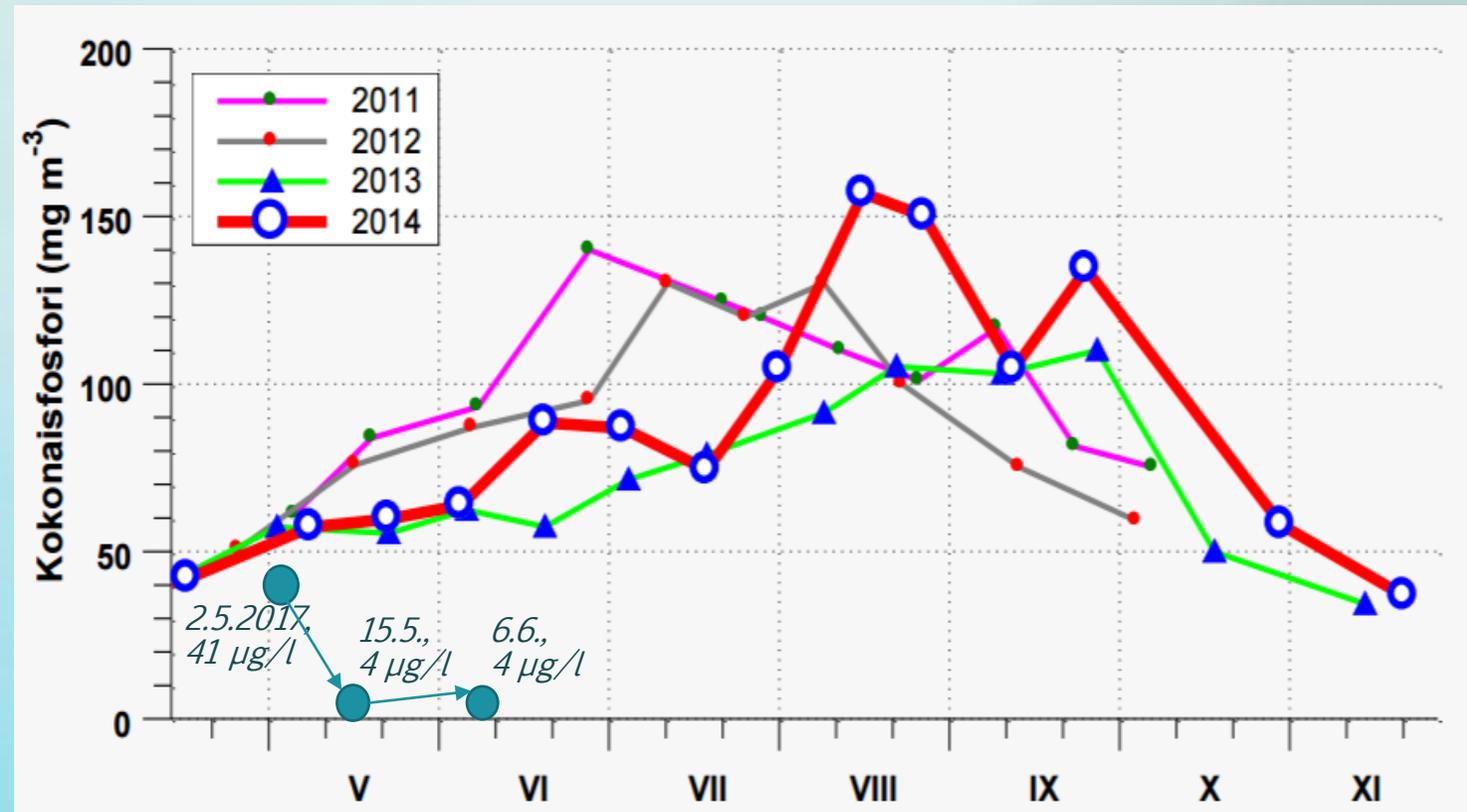
Three days vs. three weeks after: Average of three samples

Phosphorus is gone

- Last ten years: 40...160 $\mu\text{g}/\text{l}$
- 5 $\mu\text{g}/\text{l}$ (total)
- < 3 .. 8 $\mu\text{g}/\text{l}$ (soluble)
- < 3 $\mu\text{g}/\text{l}$ (phosphate)

Aluminium

- Last ten years: 100 $\mu\text{g}/\text{l}$
- 630 $\mu\text{g}/\text{l}_{15.5}$. -> 45 $\mu\text{g}/\text{l}_{6.6}$.
 - 3x drinking water guidance value; below the levels of Finnish acidified lakes, now lowest ever measured

Alkalinity very low

- Last ten years: 0,4...0,6 mmol/l
- < 0,04 mmol/l_{15.5}. -> 0,13 mmol/l_{6.6}.

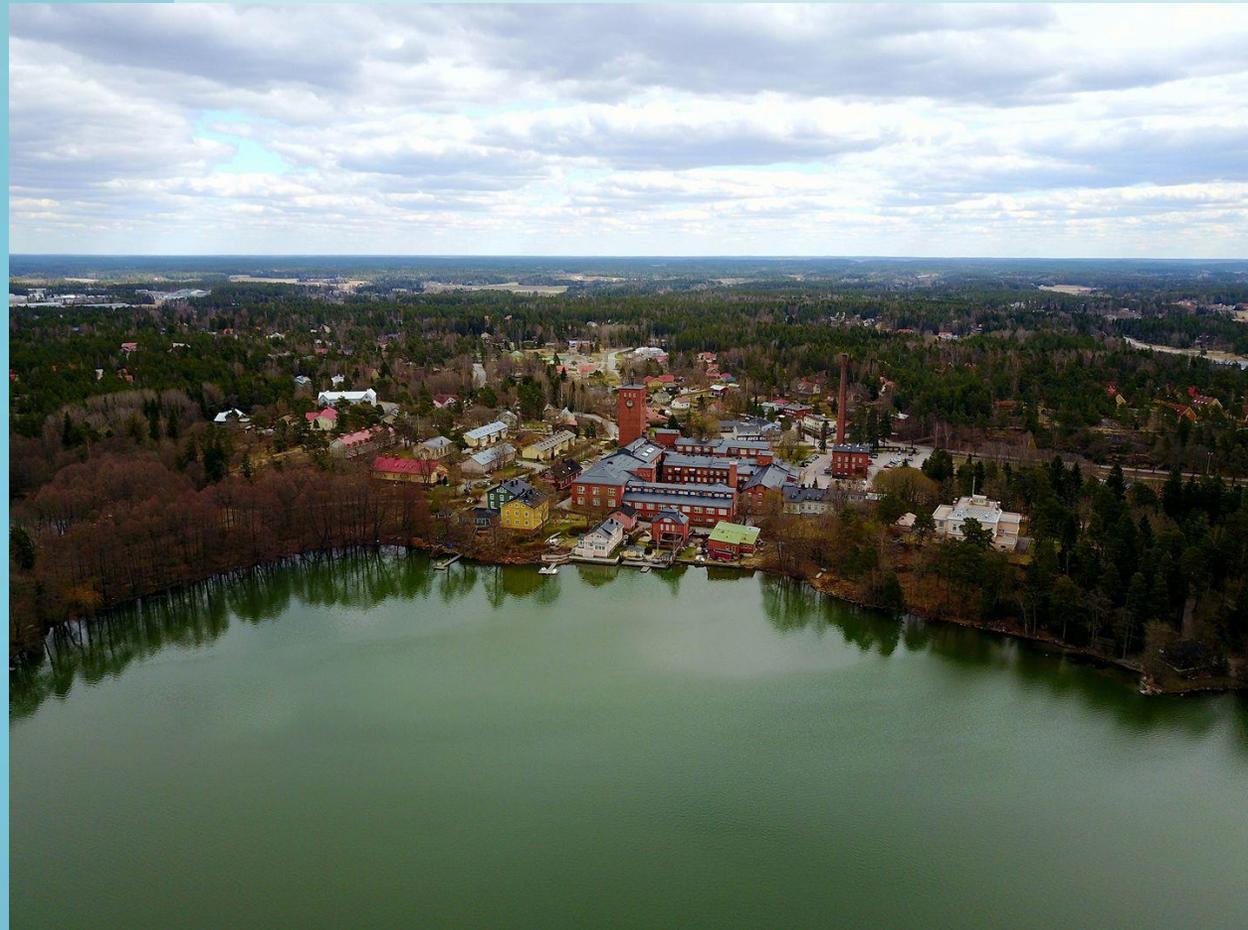
Before, May 2017

- visibility 0,3m
- FNU 4,5...5,1

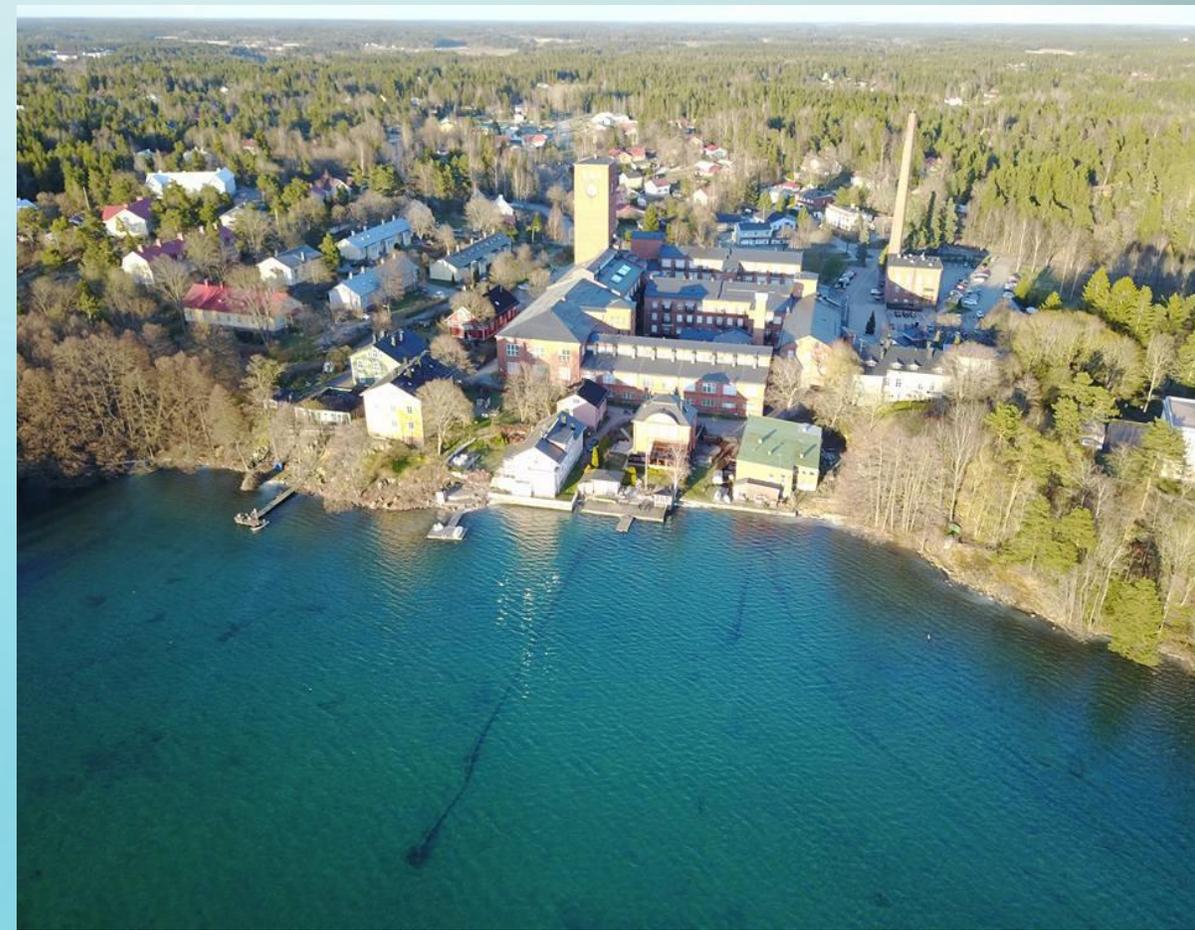
After, May 2017

Early June:

- visibility 1-3m,
- FNU 1,3...2,1
